20 June 2006
Reference: DB/SB/A1025

COURT GATE
TAVISTOCK

ASBESTOS SURVEY REPORT

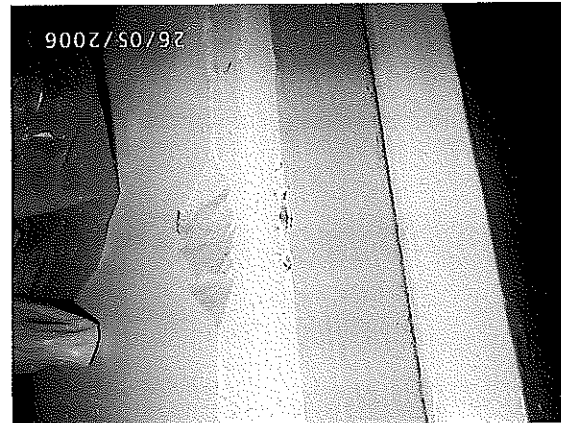
Ref: TTC-CGMU-1

Site Ref No	Laboratory Reference No	Sample Location and Description	Analysis Result	Classification
TTC-CGMU-1	T603773	G/F store - Door lining	Chrysotile (white asbestos)	Asbestos
			Amosite (brown asbestos)	insulating board
